Mars Climate Orbiter

Mishap Investigation Board

Phase I Report

November 10, 1999

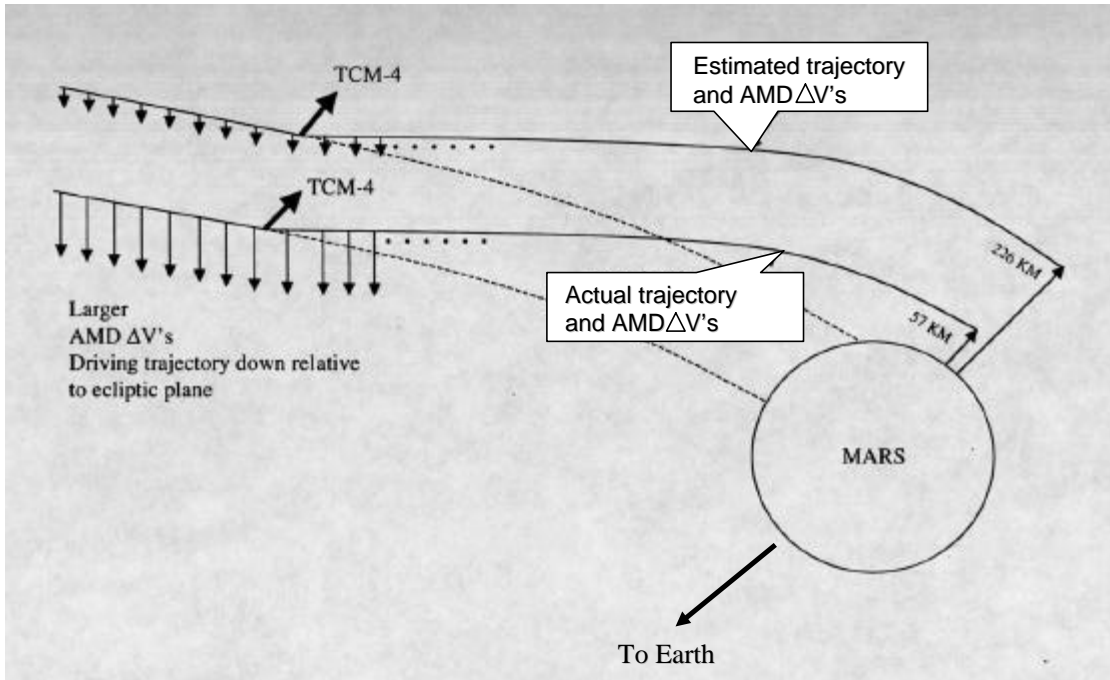
Figure 4

The MCO had been on a trajectory toward Mars since its launch on December 11, 1998. All spacecraft systems had been performing nominally until an abrupt loss of mission shortly after the start of the Mars Orbit Insertion burn on September 23, 1999.

On September 8, 1999, the final planned interplanetary Trajectory Correction Maneuver-4 (TCM-4) was computed. This maneuver was expected to adjust the trajectory such that soon after the Mars orbital insertion (MOI) burn, the first periapse altitude (point of closest approach to the planet) would be at a distance of 226km. See figure 4. This would have also resulted in the second periapse altitude becoming 210km, which was desired for the subsequent MCO aerobraking phase. TCM-4 was executed as planned on September 15, 1999.

Schematic MCO Encounter Diagram
